Kalamalka Lake Boat Trials August 27, 2019

Larratt Aquatic Consulting Ltd. 2605 Campbell Rd. West Kelowna B.C. V1Z 1T1

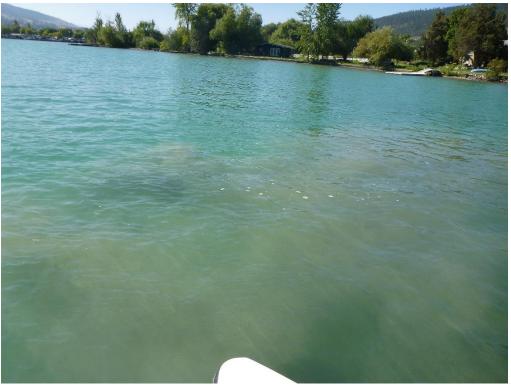
Figure 2: Re-suspended sediment visible from the wake-surf boat

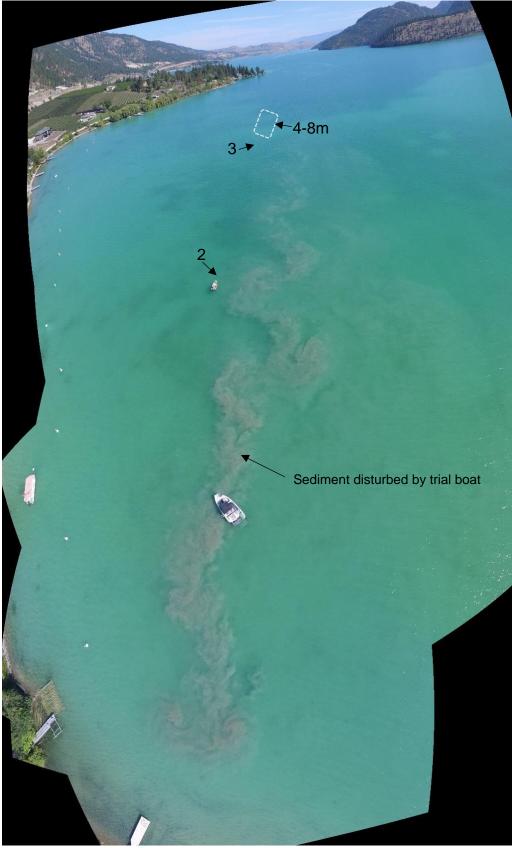
Figure 3: Buoy line through Kalamalka Lake Bay from 1 m to 8 m.

The sediments of Kalamalka Lake are very fine and resuspend readily. This was clearly demonstrated during the trial in the aerial imagery (Figure 2-4). Over the course of the trial the boat created a dramatic plume of re-suspended sediment along the buoy-line (Figure 3). This plume was also visible from the water but it was less clear and would not be noticed unless the boat returned to where they had been and stopped (Figure 2). The fine nature of Kalamalka Lake sediments mean this plume would be slow to resettle and would move into deeper water based on its relatively higher density compared to surrounding water. Given the location of the District of Lake Country intake, there is significant potential for a plume generated by a boat operating in the shallows to impact the intake (Figure 1).

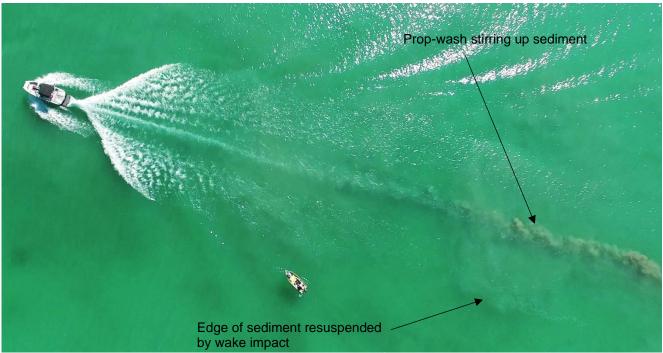
Using aerial imagery, the dual impact of the prop-wash and boat wake on the sediment were demonstrated (Figure 8). The prop-wash created a very intense plume of sediment that clouded the entire water column and was visible at the surface (Figures 2, 3, and 4). The wake impact was not visible from a boat but was clear from the air and underwater.

Figure 4: Aerial image of boat, wake, and active sediment re-suspension caused by the prop-wash and wake.

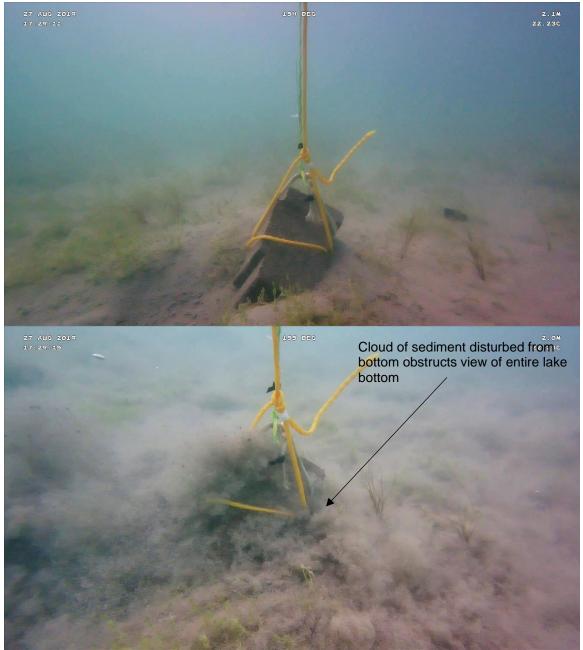
The impact of the wake from the wake-surf boat was dramatically observed impacting the sediment in 3 m or less of water (Figures 5 and 6). This represents nearly the entire southern bay.

Figure 5: Before (top) and after (bottom) impact of boat wake on sediments at 2 m

Boat operation in water <5 m deep should be conducted at low power with minimal wake generation to prevent sediment re-suspension from the boat wake turbulence and the prop-wash. Water as deep as 8 m can still be impacted by the wake. Large particulates settle quickly, sediment contaminants and bacteria settle very slowly (days) and form sediment plumes that travel down-slope to deeper water where they could impact drinking water quality at adjacent intakes.

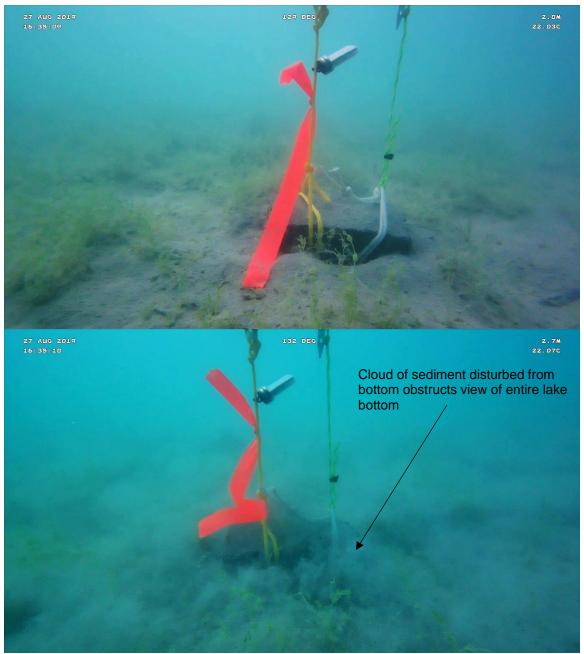
Figure 6: Before (top) and after (bottom) impact of boat wake on sediments at 3 m

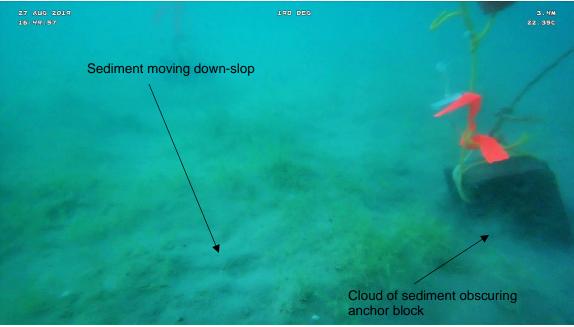
Sediment re-suspension was also observed at 4 m but the impact was less significant than at 3 m. The 4 m anchor block was resting on the drop-off slope and sediment could be seen moving down the slope with each successive wave impact.

Figure 7: Re-suspended sediment at 4 m

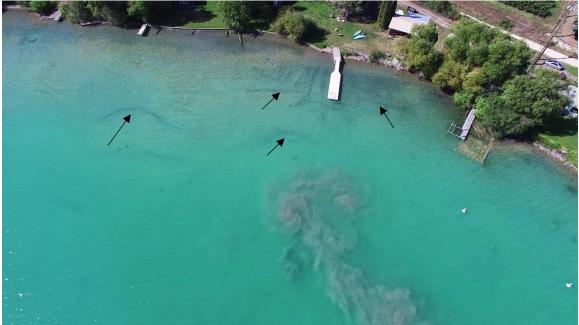
In addition to impacts generated during the trial, aerial imagery revealed the presence of scars on the lake bottom caused by previous boat disturbances.

Figure 8: Scars in the sediment from previous boat disturbances

Since the potential for sediment re-suspension is greatest in shallow bays with gentle slopes where fine sediments accumulate and stormwater discharges can contribute contaminants, power boat operators should be encouraged to avoid operating in these bays. The south bay of Kalamalka Lake is unfortunately a perfect candidate for major sediment re-suspension and the proximity to the Lake Country intake increases the risk that re-suspended sediment could impact drinking water quality.
